Thornton Accessibility Action Plan April 2023

4.1 - ACTION TABLE

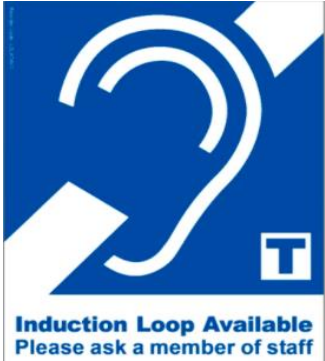
6.5	<p>Signage for an induction loop was not identified.</p> <p>Auxiliary aids can assist people who are Deaf or who have hearing loss.</p> <p>There is no induction loop provided to the reception desk in the leisure centre to accommodate hearing aid users who struggle when there is background noise.</p>

<p>Install an induction loop to the reception desk. Install signage indicating the availability of the facility and ensure that staff members are aware of how to use the system.</p> <p>Direct Access has its own bespoke desk induction loop for people with hearing impairments. We are able to supply, install and provide brief training. Please see here and contact us for more information - https://directaccessgp.co.uk/induction-loops-and-hearingenhancement-systems/</p> <p>BS8300 - A hearing enhancement system, using induction loop, infrared or radio transmission, should be installed at service or reception counters where the background noise level is high.</p>	M	Purchased awaiting install and training for staff.

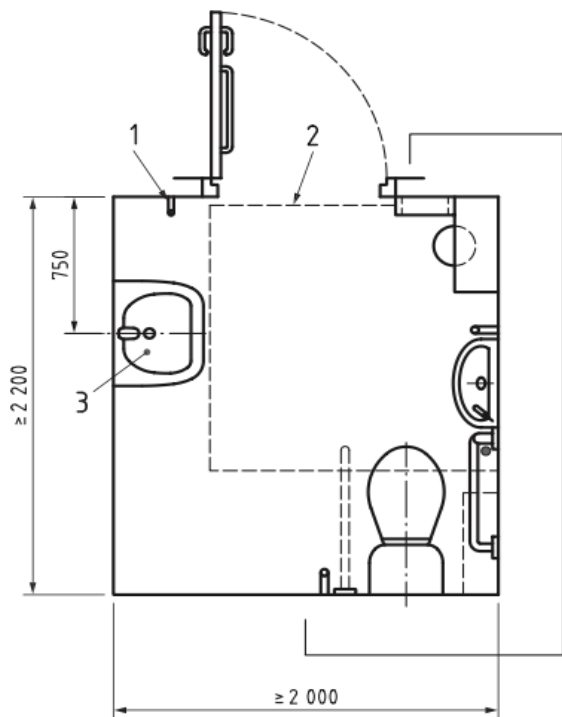
13.2	<p>Facilities were provided to the newer building of the school, on H and F Floors, as well as in Horizon.</p> <p>Further facilities were not provided to C Floor, where level access could be gained, or A Floor. This building required stepped access. Refer to section 7.3.</p> <p>The accessible facility is on the first floor in the leisure centre. No accessible facility is available on the ground floor.</p>	<p>Should level access to the old building be provided, an architectural feasibility study should be undertaken to provide a BS8300 compliant accessible WC facility within this area. A potential area location for this could be within the WC facility next to the quiet room.</p> <p>BS8300, Figure 41, should be referred to for the suggested layout and guidance.</p> <p>An alarm should be installed within the facility and the fittings should be well contrasted.</p>	M/ST

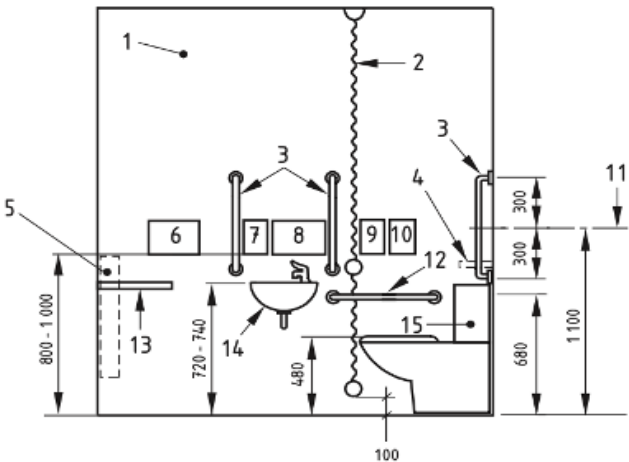
13.5 cont.

13.5	<p>The soap and tissue dispenser in the facility on H Floor were marginally high from ground floor level and were not well contrasted against the surrounding.</p> <p>The towel dispenser in the F Floor facility was high from ground floor level and were not well contrasted against the surrounding.</p> <p>The hand wash basin in the Horizon's facility was positioned too far from the toilet basin.</p> <p>The soap dispenser was also high from ground floor level.</p> <p>Fittings that are high from ground floor level may not be accessible for wheelchair users.</p> <p>The sink is not fitted near the WC pan in the leisure centre facility. This facility is set up peninsular style but with some corner style grab rails.</p>	<p>The soap, tissue and towel dispensers should be relocated at a height of between 800mm and 1000mm above finished floor level where applicable. Refer to BS8300, Figure 42 below.</p> <p>Greater contrast should be considered for the fixtures and fittings within the accessible WCs. This can be achieved by having light sanitary ware seen against a dark background or vice versa.</p> <p>⌚</p> <p>According to BS8300 - to help blind and partially sighted people identify key objects within sanitary accommodation, support rails and grab rails should contrast visually with the wall, the WC seat and cover should contrast visually with the WC pan and cistern, and sanitary fittings and accessories should contrast visually with the background against which they are seen.</p>	M

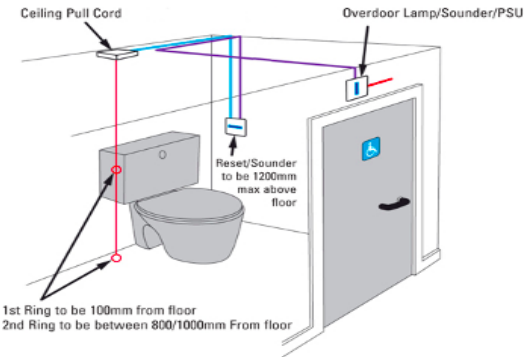
13.11	<p>The facility on H Floor was hanging within a suitable distance of the floor; however, the top bangle and reset button were high from ground floor level.</p> <p>The facility on F Floor was tied and not within a suitable distance of the floor. Should someone using the facility fall, their distress call could go unnoticed if they cannot reach the alarm.</p> <p>Bangles at two heights were not provided to the facility in Horizons. This facility also featured a reset button that was high from ground floor level.</p> <p>On the day of the survey, the cord alarm within the accessible WC of the leisure centre was obstructed by the changing bed hence should someone stumble on the floor they would not be able to reach it.</p> <p>There is no alarm cord next to the WC and the reset button is located next to the WC.</p>	<p>Implement a management procedure to ensure that cord alarms are always kept loose and not tied up.</p> <p>According to BS8300 - An emergency assistance pull cord should be sited so that it can be operated from the WC and from an adjacent floor area. The emergency assistance pull cord, coloured red, should be provided with two red bangles of 50 mm diameter, one set at a height between 800 mm and 1000 mm and the other set at 100 mm above floor level.</p>

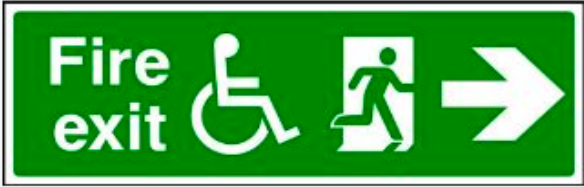
17.3	<p>This site has a sloping topography. Steps are positioned from various exit routes. The accessible egress routes were not clearly signposted within the main building.</p>	<p>Ideally, permanently ramped exits should be provided. It is acceptable in the short-term to provide suitable evacuation equipment, which is available on demand with appropriate assistance.</p> <p>Any equipment and assistance must be part of an escape plan, see 18.5, 18.6, 18.7.</p> <p>The appropriate signage should be provided to direct people to accessible exits from the school.</p>

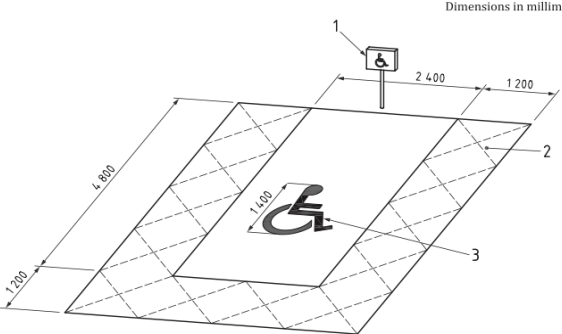
<p>2.1</p>	<p>Two accessible bays were provided to the school's carpark by the sixth form entrance.</p> <p>Bays were identified opposite the main school entrance; however, items were positioned on these bays which did not appear to be in use.</p> <p>Two further, faded bays were identified within close proximity to the main entrance. These bays did not appear to be used as designated accessible bays.</p> <p>There are four accessible bays provided within the leisure centre car park for blue badge holders.</p>	<p>Providing bays within close proximity to the main entrance may be beneficial and should be considered.</p> <p>Site management to ensure that all designated accessible parking bays are clearly marked out with at least 2.4m wide x 4.8m long plus a 1.2m side transfer zone at the side and end of the bay.</p> <p>Install a sign to the front of any accessible parking space. According to BS8300 - Sign should be present with its lower edge 1000 mm above the ground, to identify parking space when road markings are obscured, e.g. by snow or fallen leaves, with the words "Blue Badge holders only".</p>

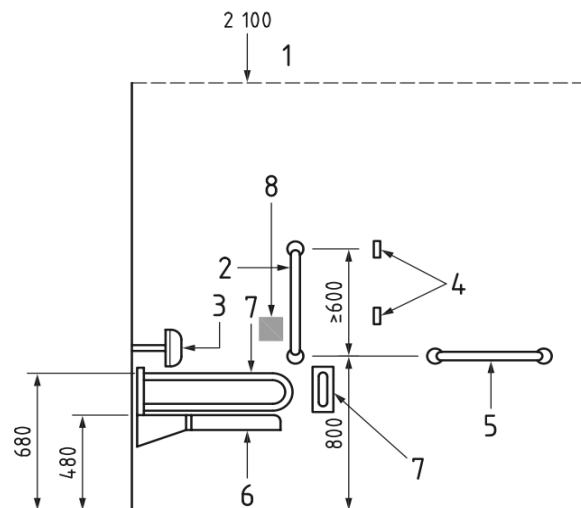
12.8
cont.

12.8	<p>The changing facilities identified did not feature a lowered section of hooks, which could assist people who are short in stature.</p> <p>For the leisure centre:</p> <p>Accessible WC and shower was provided on First Floor within the gym area.</p> <p>Main Male changing room had a larger shower cubicle which a shower chair, but no grab rails provided. An alarm was provided but the cord is not hanging loose. Locks contrasted and were lever style locks.</p> <p>Hooks were identified too high for a wheelchair user or a person of shorter stature.</p>	<p>In the changing areas, two heights of clothes hooks should be provided, one at 1050mm and the other at 1400mm above the floor. In an accessible facility, they should be located next to the mirror or to the inner face of the door.</p> <p>Grab rails should be fitted to the shower facility identified, with its lower end no higher than 800mm from ffl, as shown in BS8300 Figure 37.</p> <p>Implement a management procedure to ensure that cord alarms are always kept loose and not tied up.</p> <p>Ⓜ</p> <p>According to BS8300 - An emergency assistance pull cord should be sited so that it can be operated from the shower and from an adjacent floor area. The emergency assistance pull cord, coloured red, should be provided with two red bangles of 50 mm diameter, one set at a height between 800 mm and 1000 mm and the other set at 100 mm above floor level.</p>	M/N

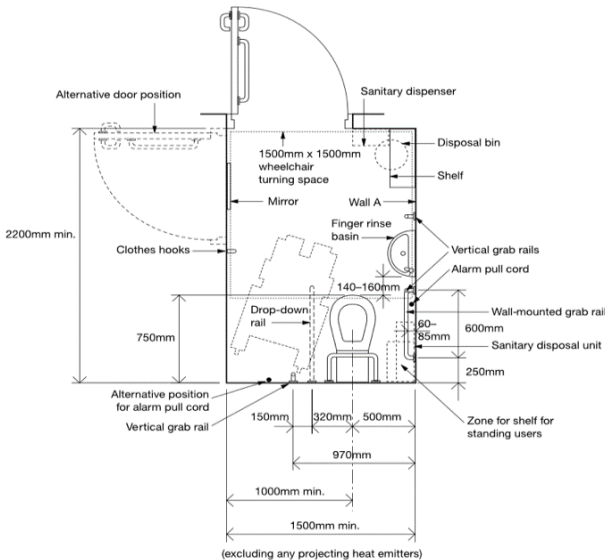
13.1

Three accessible WC facilities were provided to the school.

During future developments, the architectural feasibility of increasing the size of the accessible WCs on H and F Floor should be taken into consideration.

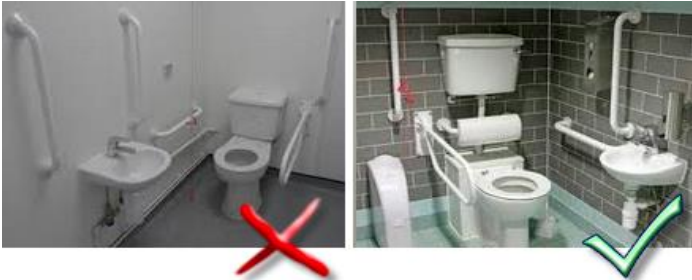
13.7	<p>Grab rails were missing to the left-hand side of the hand wash basins in F and H Floor facilities. The grab rails provided were not well contrasted against their surroundings.</p> <p>The grab rails provided in the Horizons facility were positioned appropriately for the layout and had some contrast.</p> <p>BS8300 compliant grab rails are provided throughout the accessible WC in the leisure centre, and they are well contrasted against their surround to aid people with impaired vision.</p>	<p>Grab rails should be provided either side of the washbasins, where identified. Where possible, vertical support bars at least 600mm long should be fixed each side of the washbasin, with their mid point at 1100mm above the floor.</p> <p>The grab rail sets should be replaced with a new BS8300 compliant set that offers colour contrast.</p> <p>A difference in LRV (Light Reflectance Value) between rail and background of 30 points is considered reasonable. In accessible WCs a blue rail set on white walls is a common accessible combination.</p> <div data-bbox="976 632 1666 912">

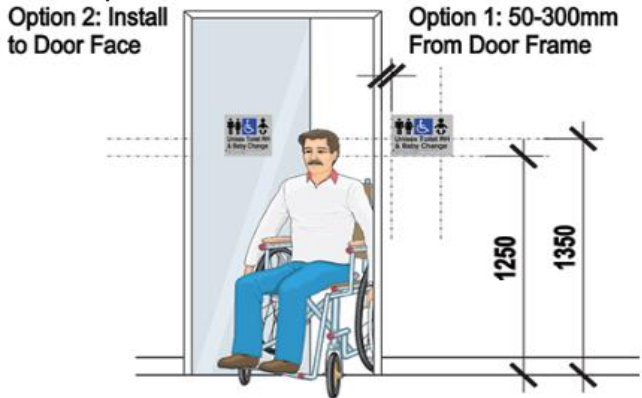
<p>WC facilities featured pictorial signage.</p> <p>Upper-case lettering was provided to some facilities, which is not best practice.</p> <p>The accessible WC signage, although pictorial, featured small images, entirely upper-case lettering and was positioned high from ground floor level on the doors.</p> <p>There is a lack of signage to indicate where the toilets are located in the leisure centre, there is no tactile or Braille signage provided on the toilet doors.</p> <p>15.3 No signage was provided to the accessible changing room and WC.</p>

<p>The appropriate accessible toilet signage should be provided as part of the recommended way finding review, refer to 15.1. As well as signage on the toilet doors, there should also be signs indicating where the accessible WCs are located.</p> <p>BS8300 states - Information and direction signs should be provided at each point where they are required, e.g. at junctions of circulation routes, at key locations such as doorways and reception points, at facilities such as telephones and toilets, and in rooms, spaces and counters. The colour, design and typeface of signs should be consistent throughout a building.</p> <p>All accessible WC door signage to be accessible to all disabled people with Braille and embossed lettering preferred.</p>

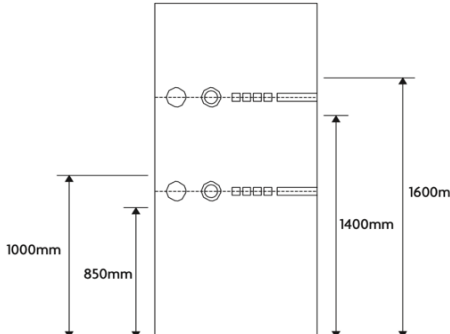
5.9	<p>A glazed entrance door was not provided to the school. Manifestations for the leisure centre main entrance may need to be improved to be visible against all backgrounds.</p>

<p>Manifestation can take various forms, e.g. broken or solid lines, patterns or company logos</p>	<p>Well contrasted manifestations should be provided at two heights to the entrance of the leisure centre.</p> <p>Glazed doors need to have permanent strips on the glass within two zones, from 850mm to 1000mm from the floor and from 1400mm to 1600mm from the floor. These strips need to be contrast in colour (not treated glass) and luminance with the background seen through the glass in all light conditions.</p>	M

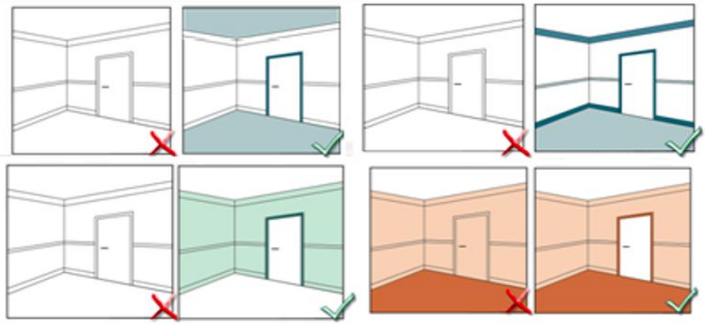
8.1	<p>Doors in the New Building were distinguishable from their surroundings.</p> <p>There are doors along B Floor that have limited contrast against their surroundings, which includes, but is not limited to, B24, B18 and B17.</p> <p>The majority of the doors in the leisure centre are suitably colour contrasted against their surroundings. No issues to report.</p>	<p>Ideally all doors should have contrast against the surroundings upon which they are seen. The doorway should be easily identifiable when the door is in the closed position, and when the door is in the open position.</p> <p>This could be achieved by painting the door frames a contrasting colour. Adding colour contrast will aid people with impaired vision.</p>

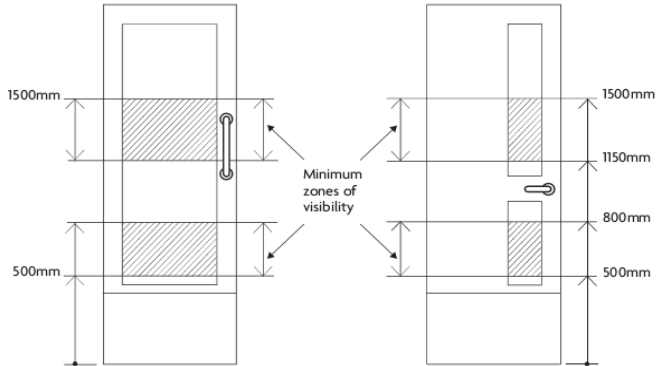
<p>8.3</p>	<p>The doors in New Building and E Floor featured suitable vision panels.</p> <p>Doors across the Old Building featured doors with high vision panels.</p> <p>High vision panels were identified across C Floor.</p> <p>Vision panels that do not extend to 500mm from ground floor level could increase the risk of a collision hazard.</p> <p>Key doors throughout the leisure centre have the appropriate vision panels.</p>	<p>A rolling refurbishment programme should be implemented to install new BS8300 compliant doors with vision panels.</p> <p>☐</p> <p>Vision panels need to be included in frequently used doors where privacy (toilets etc.) is not required with a minimum visibility zone between 500mm and 1500mm from floor level and located at the side of the leading edge.</p> <p>☐</p> <p>Glass should comply with BS6206.</p> <p>☐</p> <p>It is recommended that site management implement a procedure to ensure that the temporary notices are not on the vision panels. This will prevent a potential collision hazard.</p>

<p>M</p>	<p>Work plan in place to replace doors, ongoing since 2020.</p>

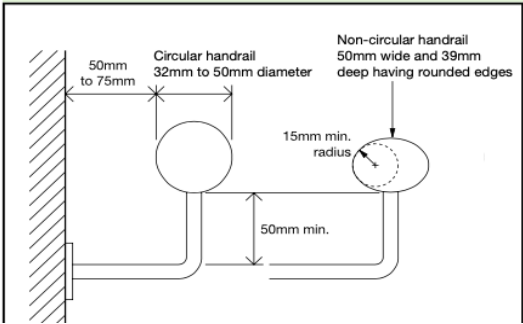
<p>10.3</p>	<p>There are sets of steps throughout the school that feature well contrasted handrails, with a suitable profile.</p> <p>The handrail provided to stairwell 1 was not extended 300 mm beyond the final step or onto the level landing.</p> <p>The two steps identified in the link corridor do not feature handrails.</p> <p>The steps opposite room B24a, by B11, opposite the staffroom, and leading towards the gymnasium feature handrails that do not extend 300mm beyond the final step.</p> <p>The stairs to the right of the stage does not feature handrails to the right.</p> <p>The stairwells leading to the first floor do not have handrails that extend the entire length of the steps and into the landing areas.</p>	<p>BS8300 compliant handrails should be provided on each side of the stair flight, throughout their length (including intermediate landings) without obstructing access routes.</p> <p>The handrails need to be one with a suitable profile (circular: 40 – 45mm, oval 50mm, in diameter)</p> <p>The handrail should be installed at a height of 900mm and needs to continue horizontally at least 300mm beyond the top and the bottom and should not project into the route of travel at final landings.</p> <p>A handrail finish should be applied that can achieve a minimum of 30 points lrv (Light Reflectance Value) between handrails and background.</p> <div data-bbox="1055 759 1576 1131"> <p>Diagram 7 Handrail design</p>

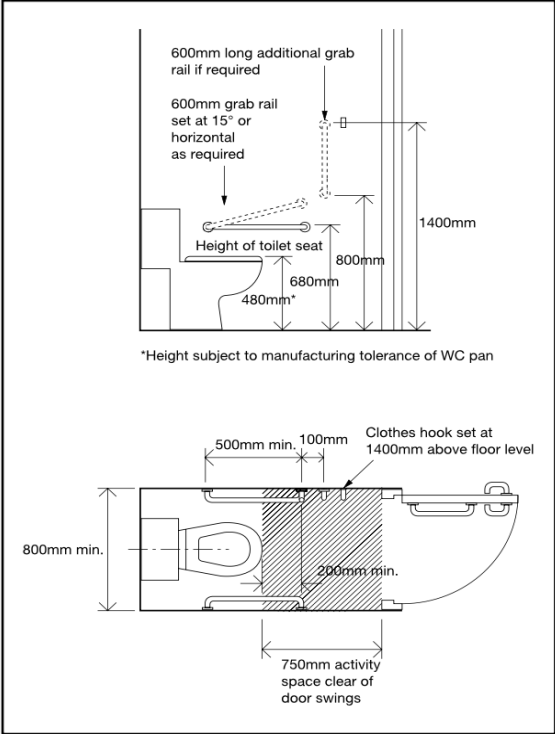
12.7	<p>Enlarged cubicles were identified in the student WC facilities near to the Year 8 team; however, these cubicles did not feature outwards opening doors or grab rails.</p>

<p>*Height subject to manufacturing tolerance of WC pan</p>	<p>As the toilets throughout the site are refurbished, there should be an internal standard or set of guidelines. These should state that any toilet being refurbished should be checked for the feasibility of including a cubicle for ambulant disabled persons.</p> <p>Any ambulant disabled cubicle provided should be AD M compliant at least 800mm wide with 750mm clear space in front of the WC pan and should include grab-rails, clothes hooks and outward opening door.</p>	M

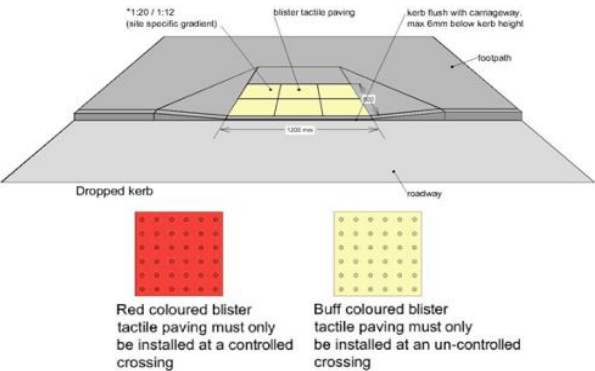
<p>1.2</p>	<p>The crossing point across the vehicle entrance to the recreation centre did not feature suitably dropped kerbs on both sides or tactile paving.</p> <p>The crossing for Southlands Avenue featured dropped kerbs, but no tactile paving.</p> <p>A pedestrian crossing is provided along Thornton Road; however, further crossing points along Leaventhorpe Lane towards the school were not identified.</p> <p>There is a crossing point with tactile paving across Thornton Road.</p>	<p>Site management should undertake liaison with the appropriate Council Department to provide tactile paving in the area and suitably dropped kerbs to aid people with impaired vision.</p>

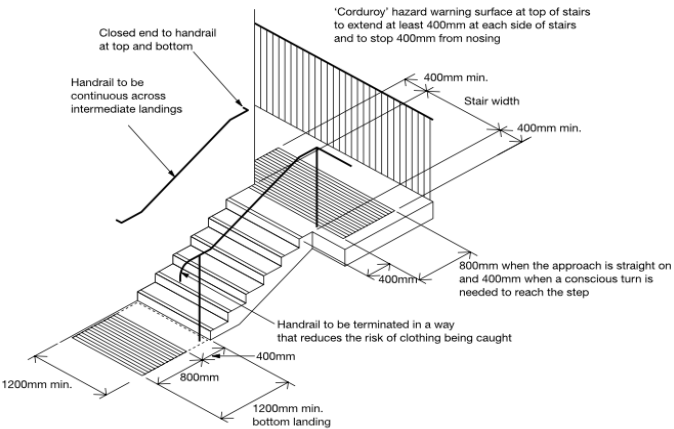
<p>4.1</p>	<p>There are external steps throughout the school that did not feature tactile warnings to the top and bottom of the flight. This included but is not limited to the main entrance steps, the steps by the sixth form exits, steps leading into the central courtyard, steps leading into the Old Building and steps leading towards D Floor.</p> <p>The tactile paving provided to the steps that lead towards the sports field were not 400mm from the step and could cause confusion.</p> <p>External steps to the leisure centre do not feature tactile paving to assist people with impaired vision.</p>	<p>Implement a rolling programme to install tactile paving to the top of the external steps throughout the site.</p> <p>BS8300 - To give advance warning of a step, tactile paving with a corduroy hazard warning surface should be provided at the top and bottom of each flight, excluding intermediate landings with continuous handrails. Where the approach to the stair is wider than the flight, the tactile surface should extend beyond the line of each edge of the flight.</p>

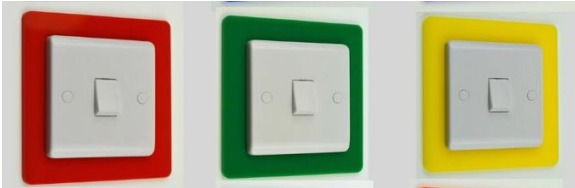
16.2	<p>There are light switch plates across the school that are not well contrasted against their surroundings. Some of which were high from ground floor level and may not be accessible for wheelchair users and people who are short in stature.</p>

<p>At the next refurbishment for the sites, it would be beneficial to change the existing light switch plates with alternatives that have a grey/silver plate. Alternatively, contrasted border could be provided. This will ensure that they are easily located by people with impaired vision.</p> <p>All switches that require precise hand movement, such as light switches, thermostats etc, should be located between 750mm – 1200mm from floor level.</p>	M
