Beckfoot Thornton School - Accessibility Action Plan.

Updated: 10/01/2025

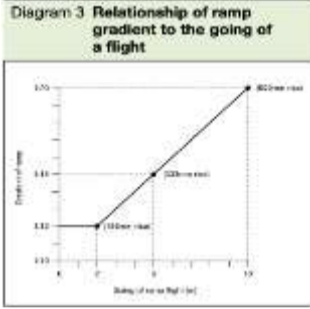
Item Ref.	Details / Issue	Recommendation	Est Cost	Action Taken
3.1	<p>Thornton School is located on a sloping site; various ramps were identified throughout the school.</p> <p>The ramps located at the main entrance, the rear sixth form entrance, and towards the gates that separate the school from the leisure centre, were suitably graded.</p> <p>The ramp leading towards the sports fields, near to the main pedestrian gate, was steep and uneven, which may not be suitable for a wheelchair user.</p> <p>The ramp to the front of the canteen was slightly steep and may not be suitable for all wheelchair users.</p>	<p>The external ramps identified should be subject to remedial works to reduce the gradient to a reasonable slope that can comply with BS8300 and ADM-2:1.26 requirements.</p> <p>Any permanent ramp must be a maximum 1:12 over a maximum going of 2m, it should be a minimum 1.2m wide and feature 1.2m landings at head and foot, handrails to both sides and a contrasted sloped surface.</p> <div style="text-align: center;">

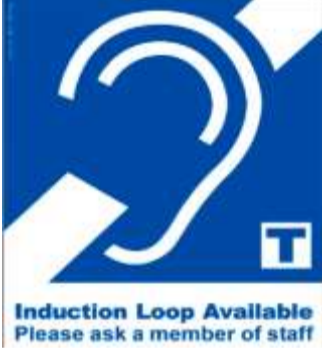
6.5	<p>Signage for an induction loop was not identified.</p> <p>Auxiliary aids can assist people who are Deaf or who have hearing loss.</p> <p>There is no induction loop provided to the reception desk in the leisure centre to accommodate hearing aid users who struggle when there is background noise.</p> <div style="text-align: center;">

</div>	<p>Install an induction loop to the reception desk. Install signage indicating the availability of the facility and ensure that staff members are aware of how to use the system.</p> <p>Direct Access has its own bespoke desk induction loop for people with hearing impairments. We are able to supply, install and provide brief training. Please see here and contact us for more information - https://directaccessgp.co.uk/induction-loops-and-hearingenhancement-systems/</p> <p>BS8300 - A hearing enhancement system, using induction loop, infrared or radio transmission, should be installed at service or reception counters where the background noise level is high.</p>	M	May-24

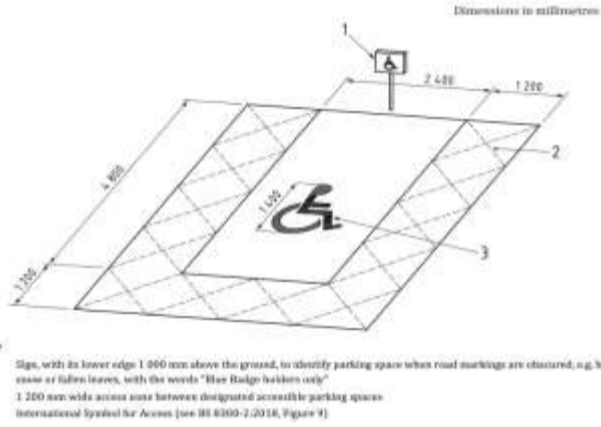
2.1	<p>Two accessible bays were provided to the school's carpark by the sixth form entrance.</p> <p>Bays were identified opposite the main school entrance; however, items were positioned on these bays which did not appear to be in use.</p> <p>Two further, faded bays were identified within close proximity to the main entrance. These bays did not appear to be used as designated accessible bays.</p> <p>There are four accessible bays provided within the leisure centre car park for blue badge holders.</p>	<p>Providing bays within close proximity to the main entrance may be beneficial and should be considered.</p> <p>Site management to ensure that all designated accessible parking bays are clearly marked out with at least 2.4m wide x 4.8m long plus a 1.2m side transfer zone at the side and end of the bay.</p> <p>Install a sign to the front of any accessible parking space. According to BS8300 - Sign should be present with its lower edge 1000 mm above the ground, to identify parking space when road markings are obscured, e.g. by snow or fallen leaves, with the words "Blue Badge holders only".</p>

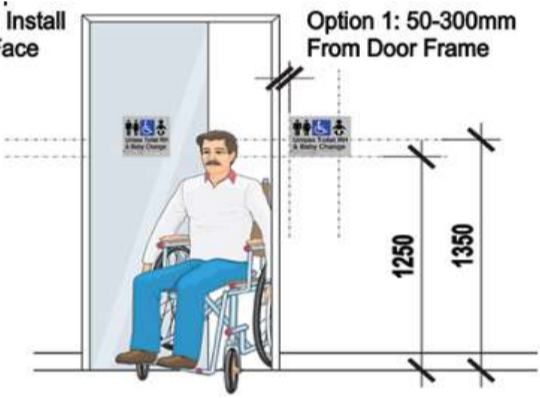
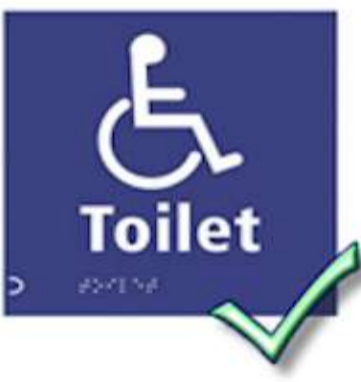
15.3	<p>WC facilities featured pictorial signage.</p> <p>Upper-case lettering was provided to some facilities, which is not best practice.</p> <p>The accessible WC signage, although pictorial, featured small images, entirely upper-case lettering and was positioned high from ground floor level on the doors.</p> <p>There is a lack of signage to indicate where the toilets are located in the leisure centre, there is no tactile or Braille signage provided on the toilet doors.</p> <p>No signage was provided to the accessible changing room and WC.</p>

<p>The appropriate accessible toilet signage should be provided as part of the recommended way finding review, refer to 15.1. As well as signage on the toilet doors, there should also be signs indicating where the accessible WCs are located.</p> <p>BS8300 states - Information and direction signs should be provided at each point where they are required, e.g. at junctions of circulation routes, at key locations such as doorways and reception points, at facilities such as telephones and toilets, and in rooms, spaces and counters. The colour, design and typeface of signs should be consistent throughout a building.</p> <p>All accessible WC door signage to be accessible to all disabled people with Braille and embossed lettering preferred.</p>

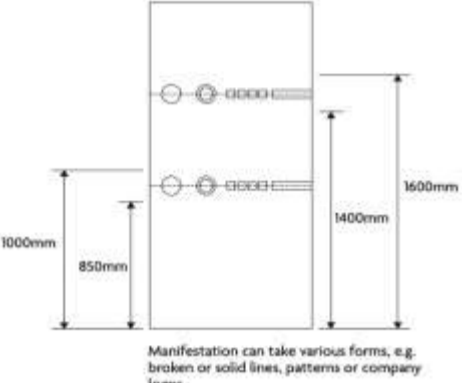
5.9	<p>A glazed entrance door was not provided to the school. Manifestations for the leisure centre main entrance may need to be improved to be visible against all backgrounds.</p>

<p>Manifestation can take various forms, e.g. broken or solid lines, patterns or company logos.</p>	<p>Well contrasted manifestations should be provided at two heights to the entrance of the leisure centre.</p> <p>Glazed doors need to have permanent strips on the glass within two zones, from 850mm to 1000mm from the floor and from 1400mm to 1600mm from the floor. These strips need to be contrast in colour (not treated glass) and luminance with the background seen through the glass in all light conditions.</p>	M

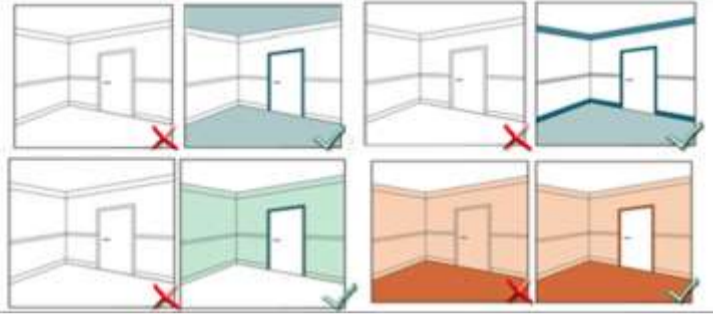
<p>8.1</p>	<p>Doors in the New Building were distinguishable from their surroundings.</p> <p>There are doors along B Floor that have limited contrast against their surroundings, which includes, but is not limited to, B24, B18 and B17.</p> <p>The majority of the doors in the leisure centre are suitably colour contrasted against their surroundings. No issues to report.</p>	<p>Ideally all doors should have contrast against the surroundings upon which they are seen. The doorway should be easily identifiable when the door is in the closed position, and when the door is in the open position.</p> <p>This could be achieved by painting the door frames a contrasting colour. Adding colour contrast will aid people with impaired vision.</p>

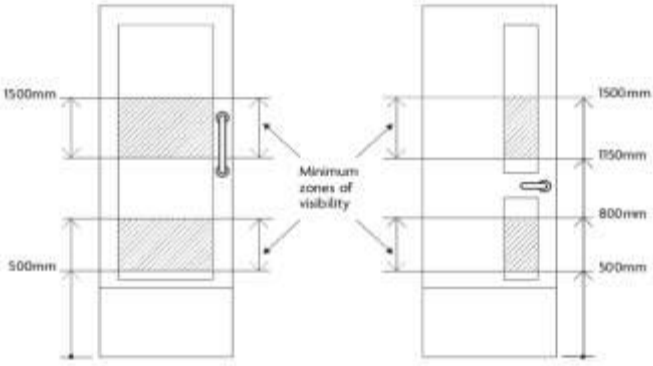
<p>M</p>	
<p>8.3</p>	<p>The doors in New Building and E Floor featured suitable vision panels.</p> <p>Doors across the Old Building featured doors with high vision panels.</p> <p>High vision panels were identified across C Floor.</p> <p>Vision panels that do not extend to 500mm from ground floor level could increase the risk of a collision hazard.</p> <p>Key doors throughout the leisure centre have the appropriate vision panels.</p>	<p>A rolling refurbishment programme should be implemented to install new BS8300 compliant doors with vision panels.</p> <p>☒ Vision panels need to be included in frequently used doors where privacy (toilets etc.) is not required with a minimum visibility zone between 500mm and 1500mm from floor level and located at the side of the leading edge.</p> <p>☒ Glass should comply with BS6206.</p> <p>☒ It is recommended that site management implement a procedure to ensure that the temporary notices are not on the vision panels. This will prevent a potential collision hazard.</p>

<p>M</p>	<p>Work plan in place to replace doors, ongoing since 2020.</p>

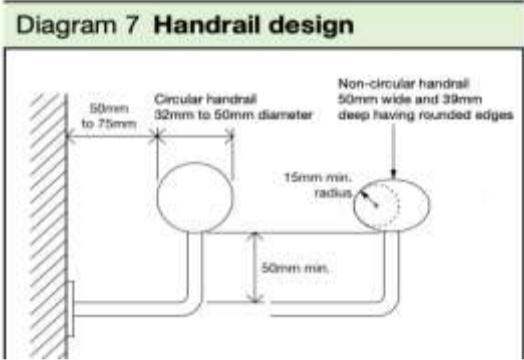
10.3	<p>There are sets of steps throughout the school that feature well contrasted handrails, with a suitable profile.</p> <p>The handrail provided to stairwell 1 was not extended 300 mm beyond the final step or onto the level landing.</p> <p>The two steps identified in the link corridor do not feature handrails.</p> <p>The steps opposite room B24a, by B11, opposite the staffroom, and leading towards the gymnasium feature handrails that do not extend 300mm beyond the final step.</p> <p>The stairs to the right of the stage does not feature handrails to the right.</p> <p>The stairwells leading to the first floor do not have handrails that extend the entire length of the steps and into the landing areas.</p>	<p>BS8300 compliant handrails should be provided on each side of the stair flight, throughout their length (including intermediate landings) without obstructing access routes.</p> <p>The handrails need to be one with a suitable profile (circular: 40 – 45mm, oval 50mm, in diameter)</p> <p>The handrail should be installed at a height of 900mm and needs to continue horizontally at least 300mm beyond the top and the bottom and should not project into the route of travel at final landings.</p> <p>A handrail finish should be applied that can achieve a minimum of 30 points lrv (Light Reflectance Value) between handrails and background.</p>

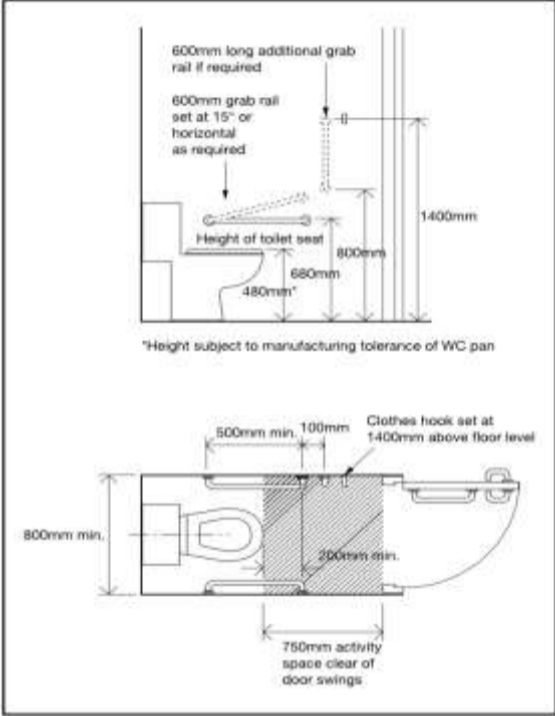
12.7	<p>Enlarged cubicles were identified in the student WC facilities near to the Year 8 team; however, these cubicles did not feature outwards opening doors or grab rails.</p>

<p>As the toilets throughout the site are refurbished, there should be an internal standard or set of guidelines. These should state that any toilet being refurbished should be checked for the feasibility of including a cubicle for ambulant disabled persons.</p> <p>Any ambulant disabled cubicle provided should be AD M compliant at least 800mm wide with 750mm clear space in front of the WC pan and should include grab-rails, clothes hooks and outward opening door.</p>	M

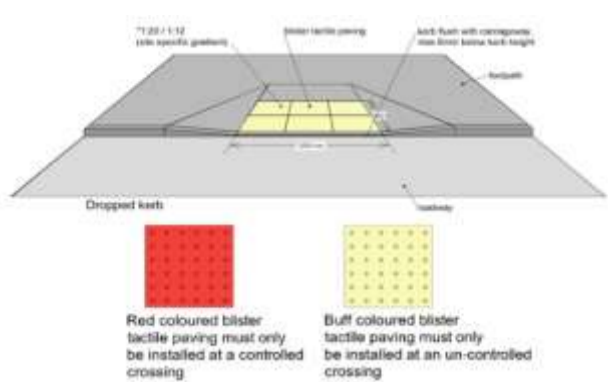
PRIORITY D				
1.2	<p>The crossing point across the vehicle entrance to the recreation centre did not feature suitably dropped kerbs on both sides or tactile paving.</p> <p>The crossing for Southlands Avenue featured dropped kerbs, but no tactile paving.</p> <p>A pedestrian crossing is provided along Thornton Road; however, further crossing points along Leaventhorpe Lane towards the school were not identified.</p> <p>There is a crossing point with tactile paving across Thornton Road.</p>	<p>Site management should undertake liaison with the appropriate Council Department to provide tactile paving in the area and suitably dropped kerbs to aid people with impaired vision.</p>

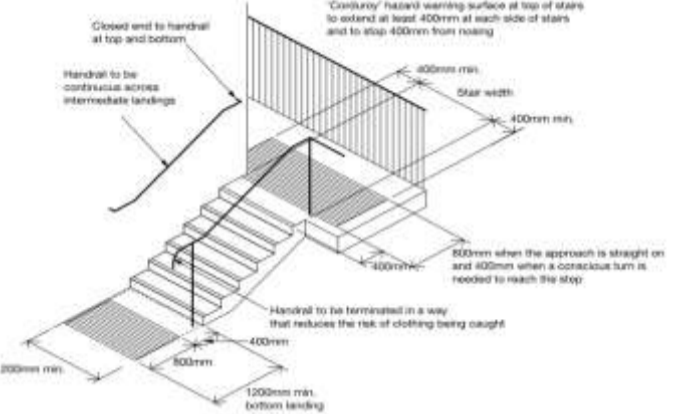
<p>4.1</p>	<p>There are external steps throughout the school that did not feature tactile warnings to the top and bottom of the flight. This included but is not limited to the main entrance steps, the steps by the sixth form exits, steps leading into the central courtyard, steps leading into the Old Building and steps leading towards D Floor.</p> <p>The tactile paving provided to the steps that lead towards the sports field were not 400mm from the step and could cause confusion.</p> <p>External steps to the leisure centre do not feature tactile paving to assist people with impaired vision.</p>	<p>Implement a rolling programme to install tactile paving to the top of the external steps throughout the site.</p> <p>BS8300 - To give advance warning of a step, tactile paving with a corduroy hazard warning surface should be provided at the top and bottom of each flight, excluding intermediate landings with continuous handrails. Where the approach to the stair is wider than the flight, the tactile surface should extend beyond the line of each edge of the flight.</p>

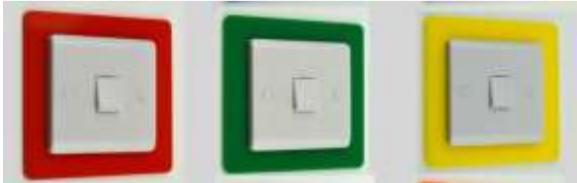
16.2	<p>There are light switch plates across the school that are not well contrasted against their surroundings. Some of which were high from ground floor level and may not be accessible for wheelchair users and people who are short in stature.</p>

<p>At the next refurbishment for the sites, it would be beneficial to change the existing light switch plates with alternatives that have a grey/silver plate. Alternatively, contrasted border could be provided. This will ensure that they are easily located by people with impaired vision.</p> <p>All switches that require precise hand movement, such as light switches, thermostats etc, should be located between 750mm – 1200mm from floor level.</p>	M
