Beckfoot Thornton School - Accessibility Action Plan.

Updated: 10/01/2025

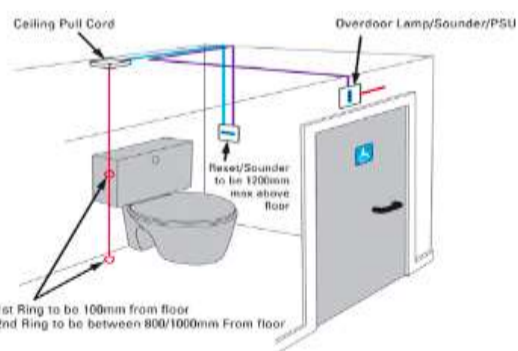
13.11	<p>The facility on H Floor was hanging within a suitable distance of the floor; however, the top bangle and reset button were high from ground floor level.</p> <p>The facility on F Floor was tied and not within a suitable distance of the floor. Should someone using the facility fall, their distress call could go unnoticed if they cannot reach the alarm.</p> <p>Bangles at two heights were not provided to the facility in Horizons. This facility also featured a reset button that was high from ground floor level.</p> <p>On the day of the survey, the cord alarm within the accessible WC of the leisure centre was obstructed by the changing bed hence should someone stumble on the floor they would not be able to reach it.</p> <p>There is no alarm cord next to the WC and the reset button is located next to the WC</p>	<p>Implement a management procedure to ensure that cord alarms are always kept loose and not tied up.</p> <p>According to BS8300 - An emergency assistance pull cord should be sited so that it can be operated from the WC and from an adjacent floor area. The emergency assistance pull cord, coloured red, should be provided with two red bangles of 50 mm diameter, one set at a height between 800 mm and 1000 mm and the other set at 100 mm above floor level.</p>	N	Mar-24

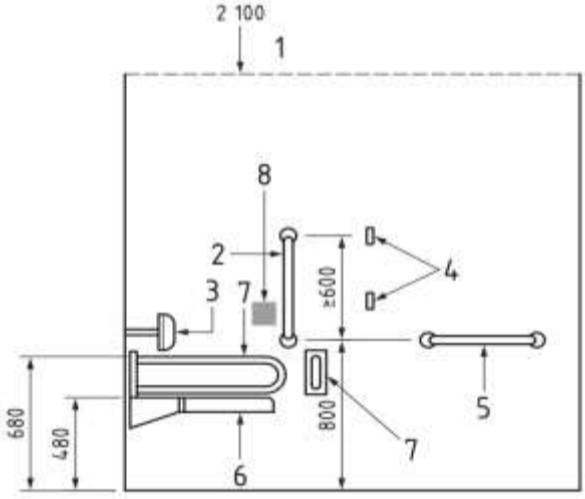
12.8 cont.

12.8	<p>The changing facilities identified did not feature a lowered section of hooks, which could assist people who are short in stature.</p> <p>For the leisure centre:</p> <p>Accessible WC and shower was provided on First Floor within the gym area.</p> <p>Main Male changing room had a larger shower cubicle which a shower chair, but no grab rails provided. An alarm was provided but the cord is not hanging loose.</p> <p>Locks contrasted and were lever style locks.</p> <p>Hooks were identified too high for a wheelchair user or a person of shorter stature.</p>	<p>In the changing areas, two heights of clothes hooks should be provided, one at 1050mm and the other at 1400mm above the floor. In an accessible facility, they should be located next to the mirror or to the inner face of the door.</p> <p>Grab rails should be fitted to the shower facility identified, with its lower end no higher than 800mm from ffl, as shown in BS8300 Figure 37.</p> <p>Implement a management procedure to ensure that cord alarms are always kept loose and not tied up.</p> <p>According to BS8300 - An emergency assistance pull cord should be sited so that it can be operated from the shower and from an adjacent floor area. The emergency assistance pull cord, coloured red, should be provided with two red bangles of 50 mm diameter, one set at a height between 800 mm and 1000 mm and the other set at 100 mm above floor level.</p>	M/N

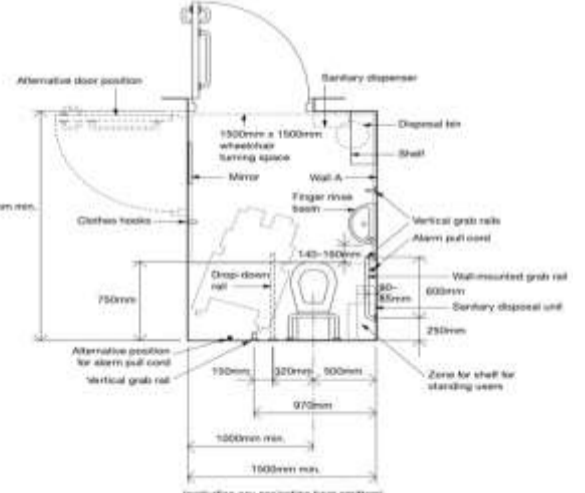
M	
13.1	<p>Three accessible WC facilities were provided to the school.</p> <p>The facility opposite H9, measured to be approximately 1470mm by 2024mm. This facility was narrowed further to approximately 1550mm structurally, narrowing the transfer zone.</p> <p>The facility on F Floor was measured to be approximately 1695mm by 1550mm.</p> <p>The facility in Horizons was measured to be approximately 2265mm by 1510mm.</p> <p>The facility on H Floor and F Floor may not be suitably sized for wheelchair users.</p> <p>An Accessible WC and changing area with hoist was available on first floor/ gym floor. Compartment dimensions 3020mm by 3470mm</p>	<p>During future developments, the architectural feasibility of increasing the size of the accessible WCs on H and F Floor should be taken into consideration.</p> <p>Refer to ADM diagrams 18 and 19 for guidance.</p>

13.1 cont.		<p>*Height subject to manufacturing tolerance of WC pan</p> <p>HD: Possible position for automatic hand dryer (see also Diagram 20) SD: Soap dispenser PT: Paper towel dispenser AR: Alarm reset button TP: Toilet paper dispenser</p> <p>Height of drop-down rails to be the same as the other horizontal grab rails</p>
